FARM REST HOUSE

Here's a series of photos and annotations to bring you up to date on the construction of the farm rest house. It will be a number of notches higher in standard than the goat house, with such improvements as coco lumber posts instead of bamboo, concrete footings, plywood flooring, walls, power and running water. Something like the beach house. There will be an outhouse for ablutions. This structure will allow us to spend a day and/or overnight at the farm. But mainly, it will also house a fridge to keep the eventual cow and goat milk after pasteurizing.

9 Dec 08

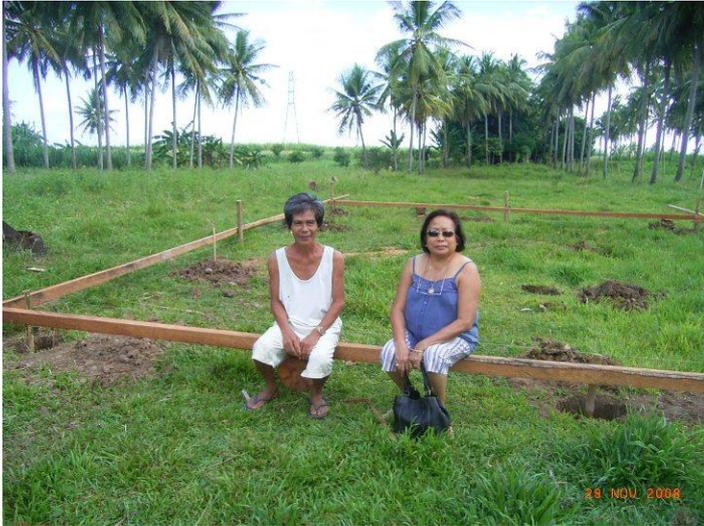
A

A. That's Moms and Nitoy with the staked-out footprint of the rest house, 30 ft x 24 ft.

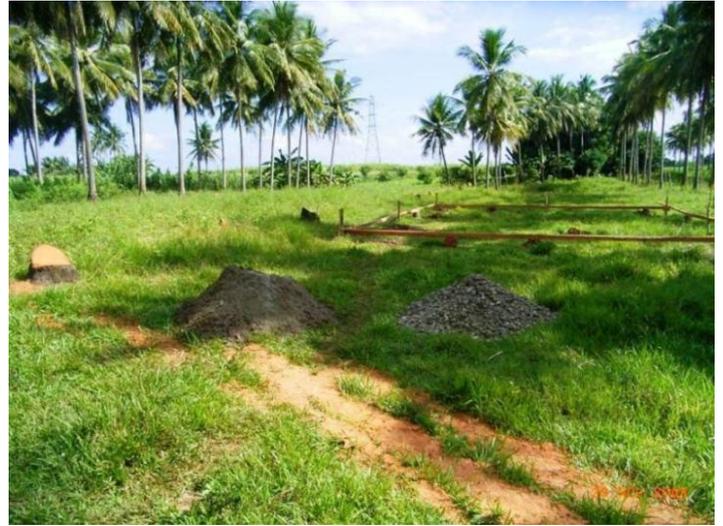
B

B. It took 15 felled coconut trees to produce the coco lumber shown in photo C. Note the line of stumps and the sawdust in the foreground. The sand and gravel mounds are for the concrete footings. One shouldn't build near a coconut tree as the fruit or leaves do fall and cause damage.

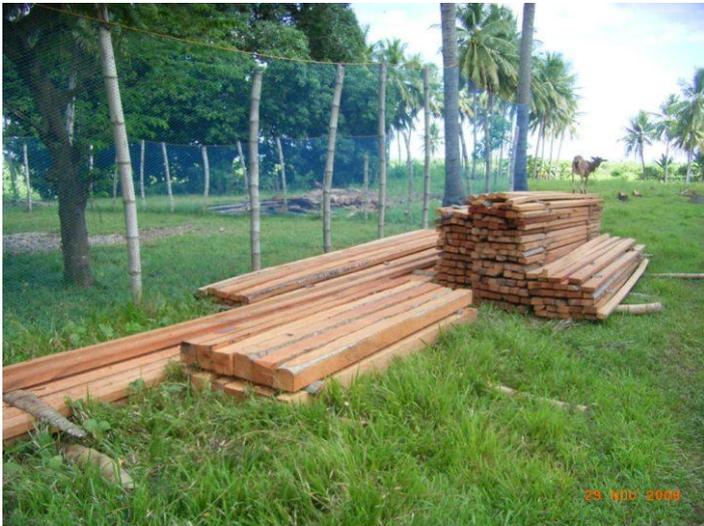
C

C. That's 1,915 board-feet of lumber cut to various sizes by a contractor who comes with a portable saw mill and cuts the tree down and into lumber. It costs P5 per board-foot (bd-ft) for this service. Buying lumber from a lumber yard is P14 per bdft, plus transportation. I haven't worked out a comparison with US pine wood, but coco lumbers seems very much cheaper. Note the goat atop the wood pile.

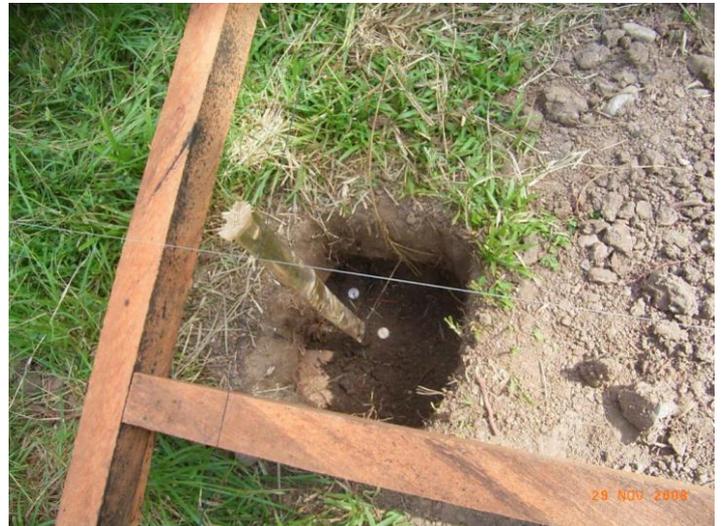
D

D. No harm in putting a few coins into the footings base.

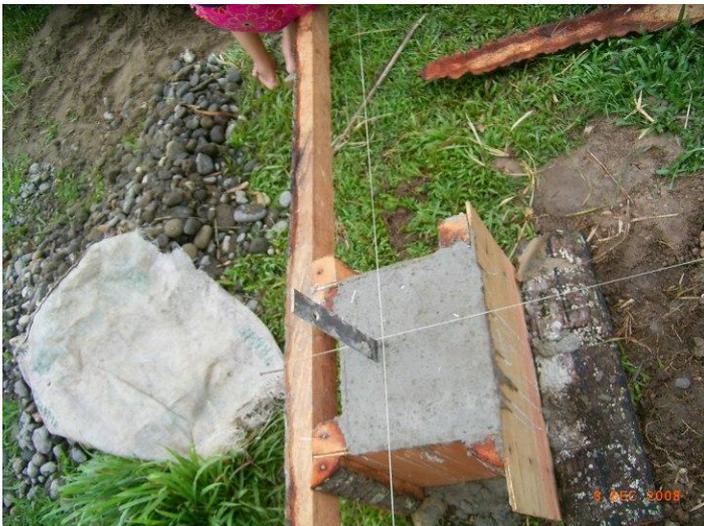
E

E. A footing after pouring the concrete; note steel strap for fixing the post.

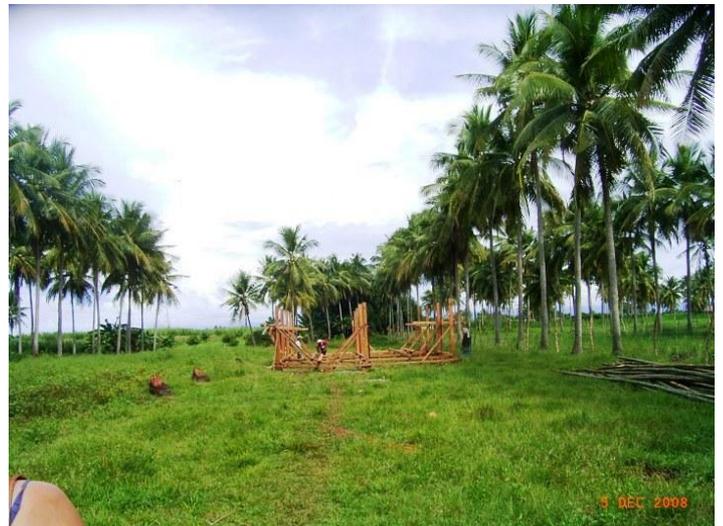
F

F. Long view after 3 days of work by the master carpenter and his 2-3 helpers; posts are up, floor joists partly complete. They are daily paid, not pacquiao work.

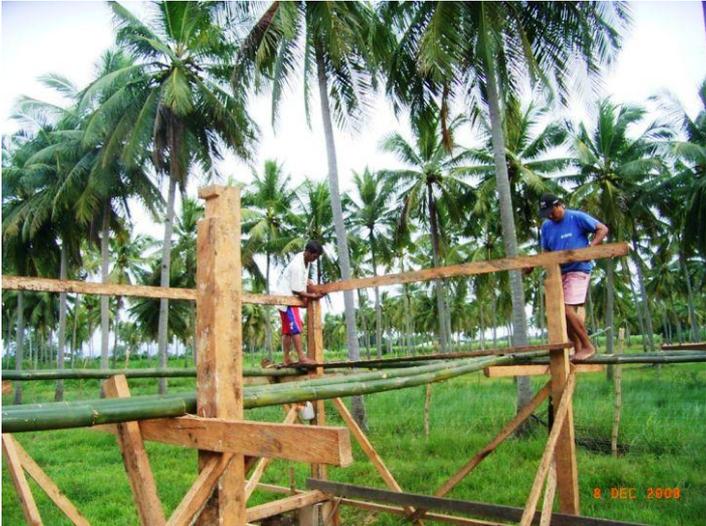
G

G. Putting in the roof chords on day 6. The bamboo is temporary scaffolding. Note the notch on the post for the chord.

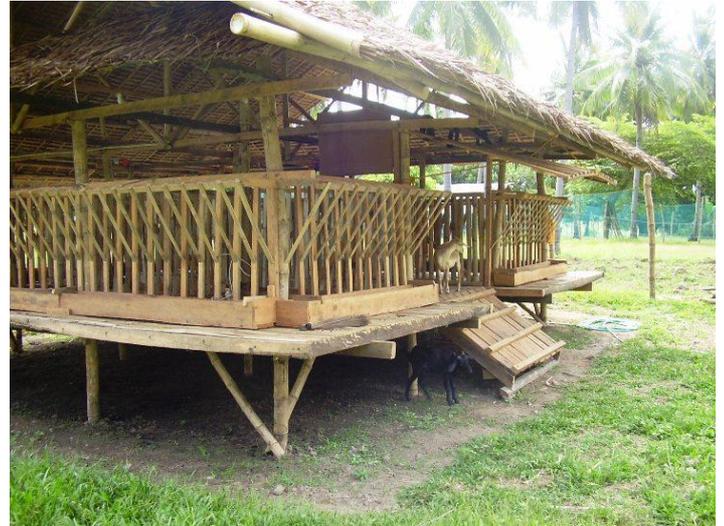
H

H. The goat house for comparison.
